Manhole Inspection Summary

Manhole # S41A__016MH

Location Address: **1255 peachleaf ct**

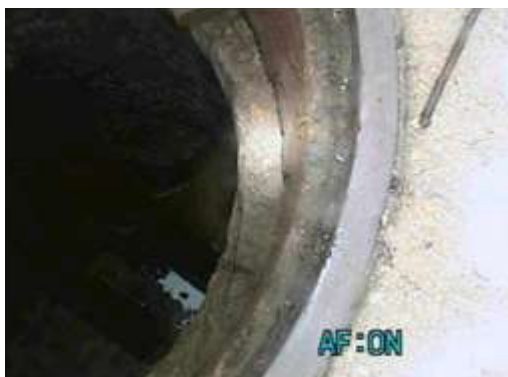
Defect 4

Offset: **2** (in.)

offset

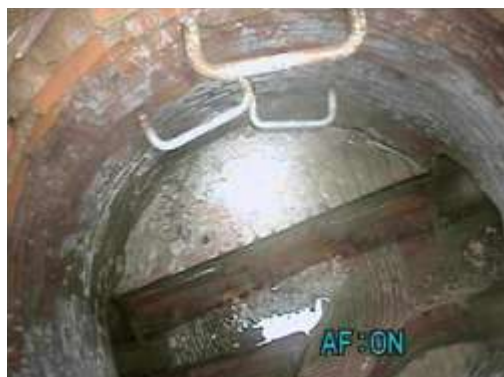
Defect 3

Count: **3** Missing: **0** ☒ **Corroded**

cor. steps

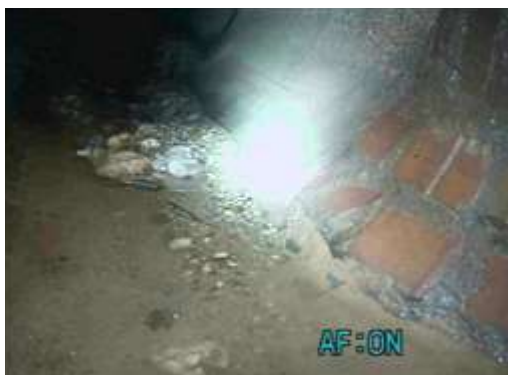
Defect 2

Condition: ☐ Sound ☐ Cracked ☐ Root Intrusion ☐ Deteriorated ☐ Leaks ☒ **Debris**

channel debris

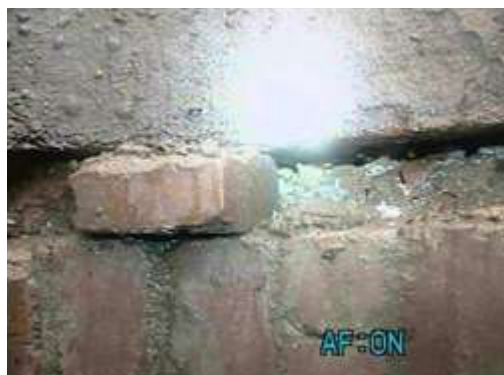
Defect 1

Condition: ☐ Sound ☐ Cracked ☒ **Leaks**

Condition: ☐ Sound ☐ Cracked ☐ Root Intrusion ☒ **Loose Brick** ☐ Deteriorated

chimney loose bricks, frame leaks, frame adj

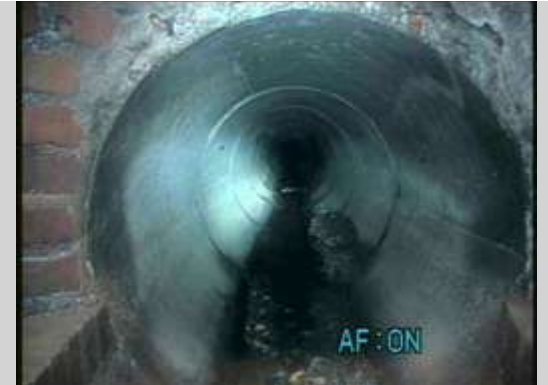
12 O'Clock Outflow

18 in. Circular Gravity Sewer
Pipe Out @ 12 O'Clock

Pipe Material: **Clay** ☐ Pipe Lined

Invert Depth: 7.25 (ft.) Flow Characteristics: **None**

Infiltration: **None** Pipe Seal Cond: **Unknown**

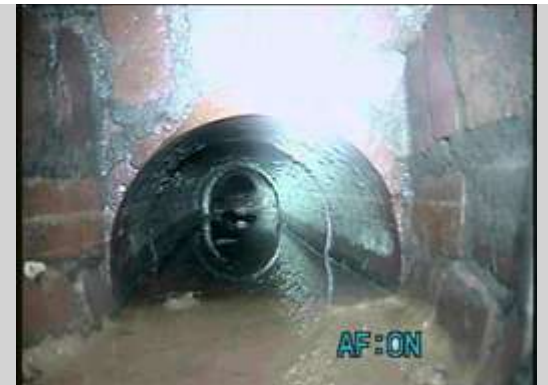
3 O'Clock Inflow

10 in. Circular Gravity Sewer
Pipe In @ 3 O'Clock

Pipe Material: **Clay** ☐ Pipe Lined

Invert Depth: 7.13 (ft.) Flow Characteristics: **None**

Infiltration: **None** Pipe Seal Cond: **Unknown**

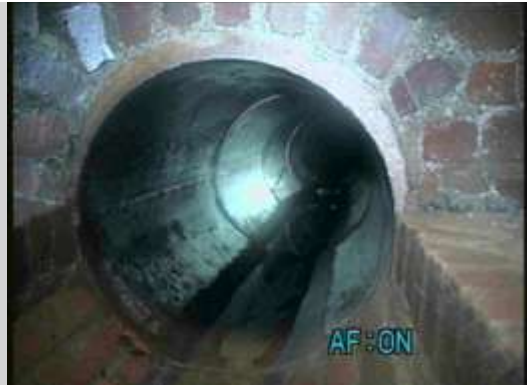
6 O'Clock Inflow

18 in. Circular Gravity Sewer
Pipe In @ 6 O'Clock

Pipe Material: **Clay** ☐ Pipe Lined

Invert Depth: **7.16** (ft.) Flow Characteristics: **None**

Infiltration: **None** Pipe Seal Cond: **Unknown**
